**FINAL
REMEDIAL ACTION REPORT**

SOURCE CONTROL REMEDIAL ACTION

**RE-SOLVE, INC. SUPERFUND SITE
NORTH DARTMOUTH, MASSACHUSETTS**

**By
Halliburton NUS Corporation
and
Raytheon Engineers & Constructors, Inc.**

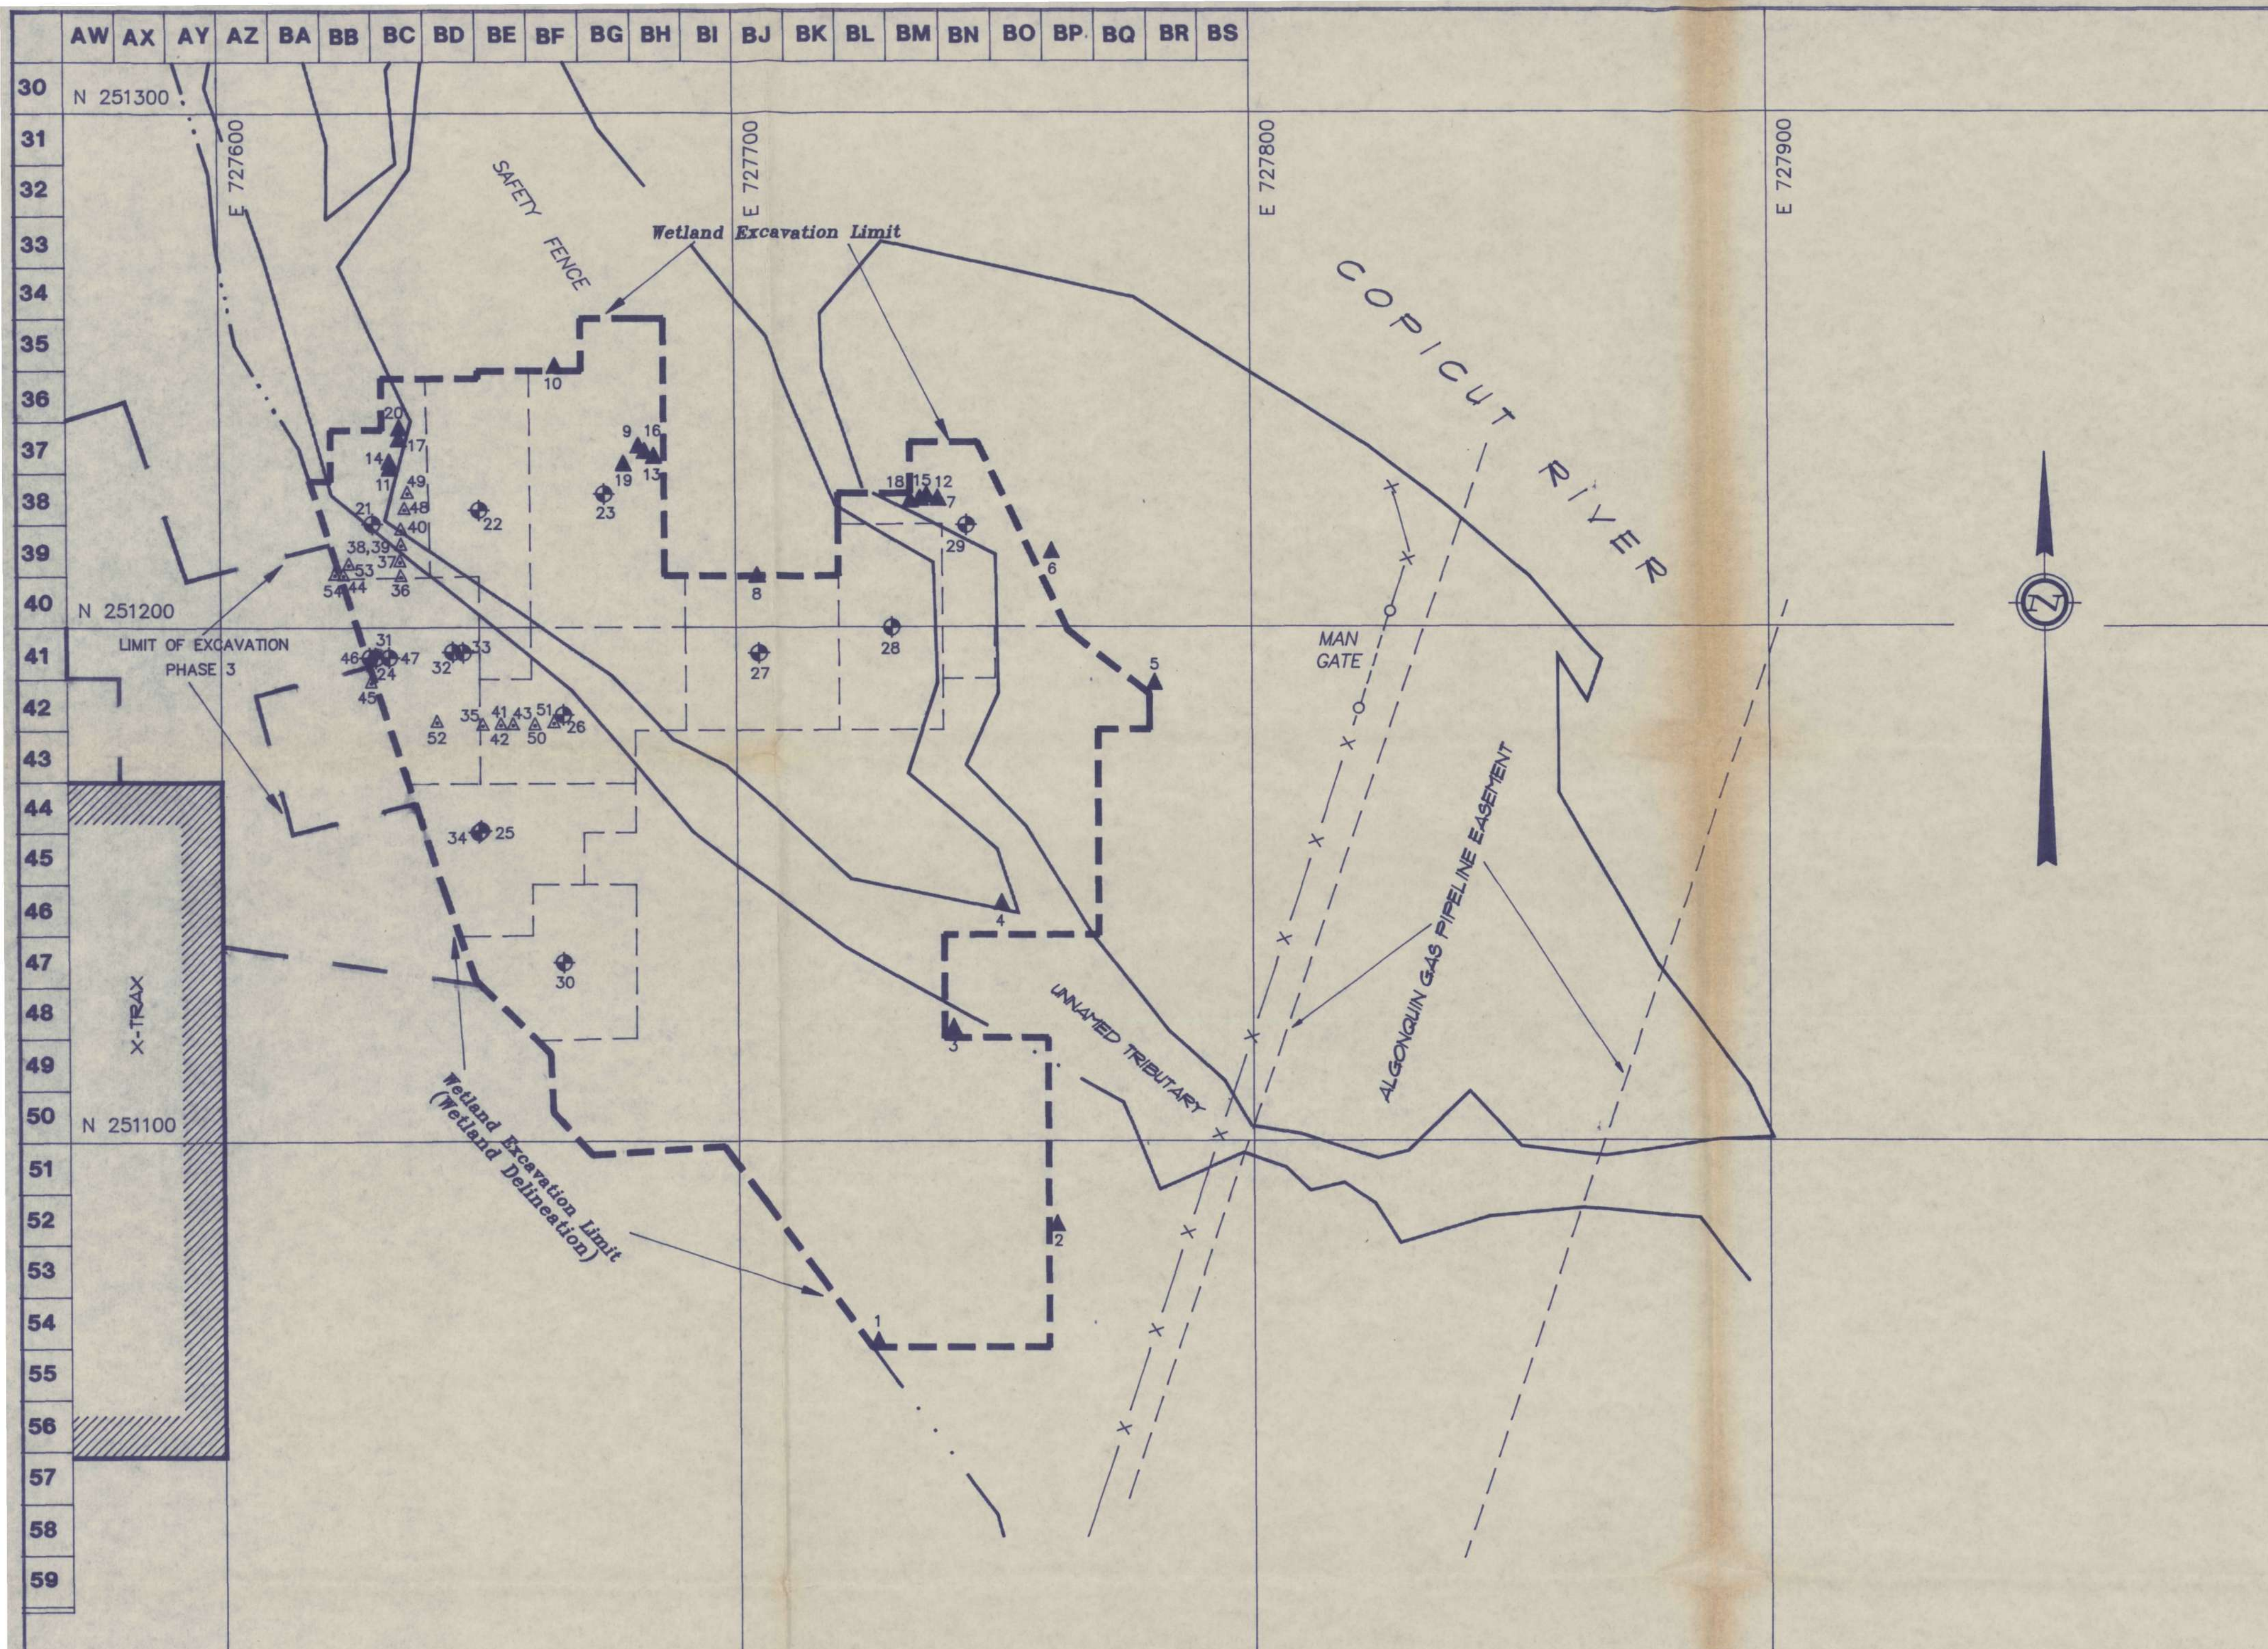
PRE-EXCAVATION SAMPLING
NORTH WETLANDS REMEDIAL AREA

PRE-EXCAVATION
SIDEWALL SAMPLES

NO.	DESCRIPTION	DATE	NORTH	EAST	ELEV. (FT.) **	PCB (PPM)	RESULT > 1ppm	FOLLOW UP SAMPLE NO.
1	PES3052401	5/24/93	251391.5	727159.1	84.6	0.2U	NO	
2	PES3052402	5/24/93	251376.6	727191.8	83.6	0.8U	NO	
3	PES3052404	5/24/93	251371.6	727285.1	83.6	0.5	NO	
4	PES3052405	5/24/93	251401.2	727303.9	83.9	6.1	YES	PES3061505(A)
5	PES3052407	5/24/93	251401.3	727366.5	83.4	0.2U	NO	
6	PES3060303	6/03/93	251371.0	727235.0	83.2	0.4U	NO	
7	PES3060306	6/03/93	251421.3	727336.4	84.2	0.1U	NO	
8	PES3060308	6/03/93	251381.1	727381.5	81.5	0.4	NO	
9	PES3061505(A)	5/15/93	251402.7	727287.3	83.7	0.1	NO

- CHAIN LINK FENCE
- LIMIT OF EXCAVATION
- LIMIT OF EXCAVATION
(PHASE 2)
- PROPERTY LINE
- WETLAND DELINEATION
- PRE-EXCAVATION SIDEWALL SAMPLE

NOTE: The limits of excavation for the North Wetlands and Phase 2 overlap.
The Phase 2 excavation occurred first. Then Wetlands excavation of the overlapped area
was conducted as necessary to assure that the required excavation depth for the Wetlands was achieved.

The Wetland Delineation Line as shown hereon
combines the outer limits of the
U.S. Army Corps of Engineers Boundary and
Bordering Vegetated Wetland Line as shown on
Plan "WETLANDS RESOURCE MAP" dated 31 Dec. '90
by DANSON SURVEYING AND ENGINEERING CO.

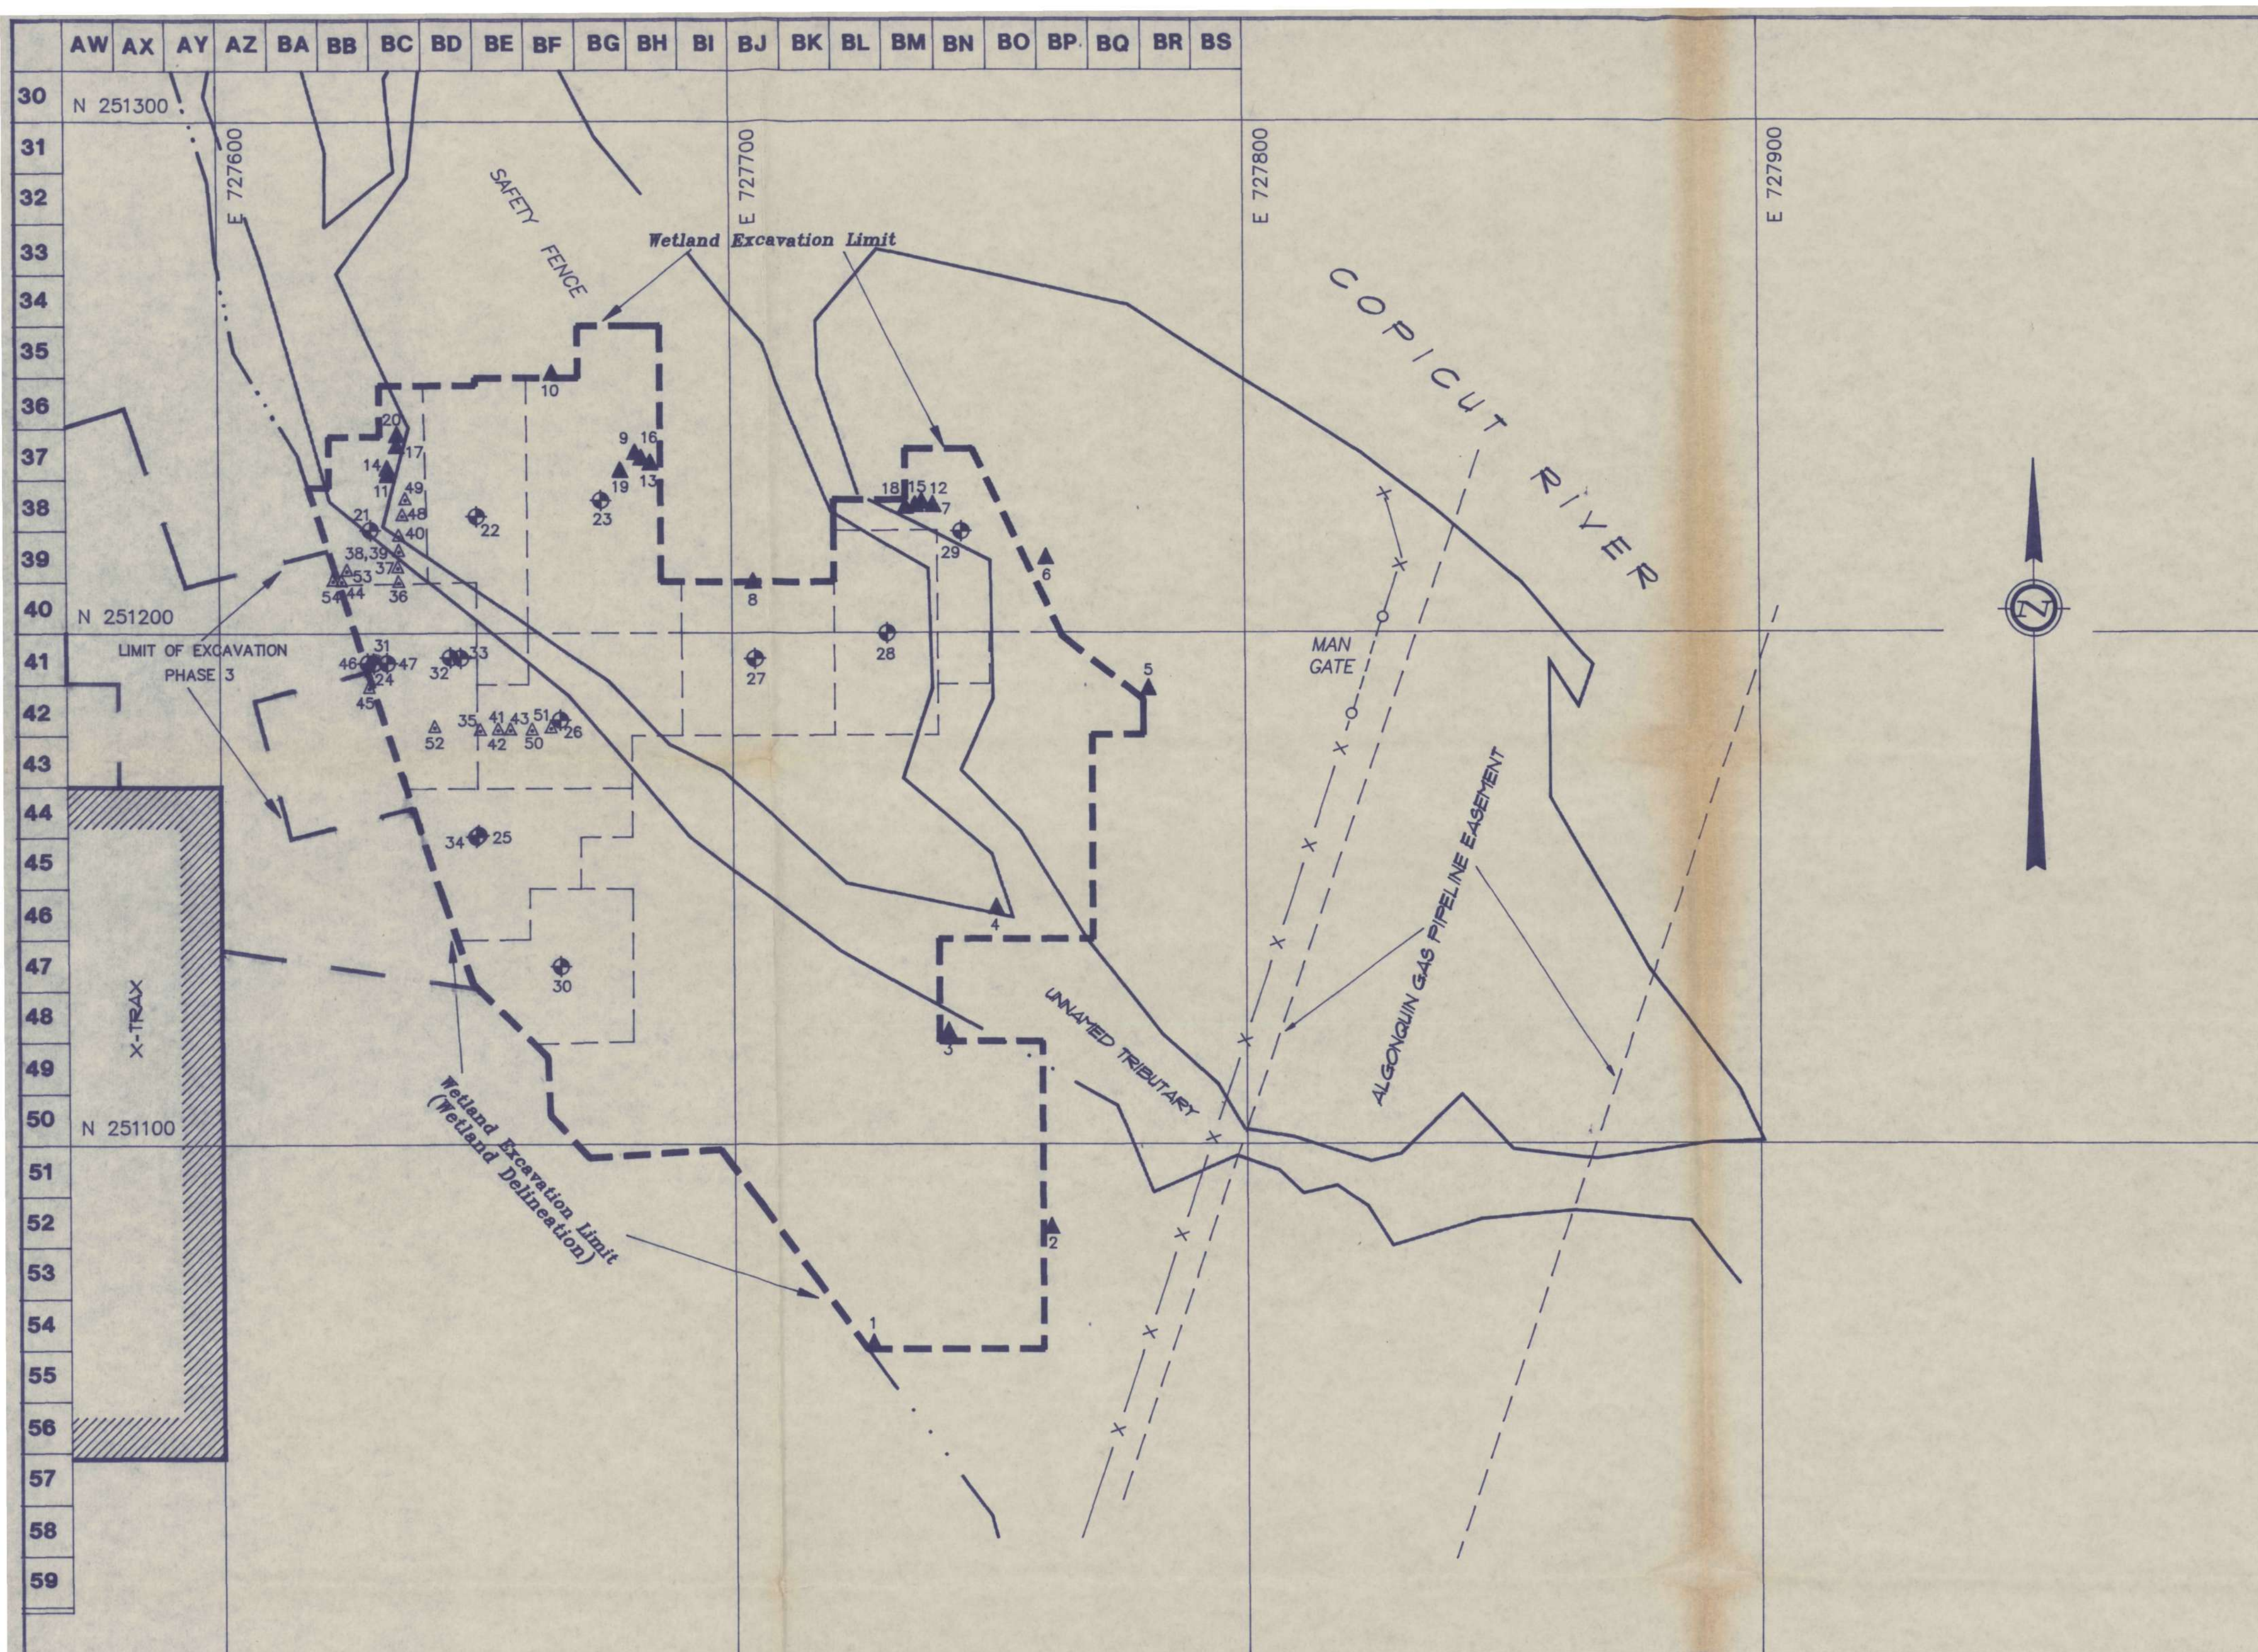
PRE & POST-EXCAVATION SAMPLING
EAST WETLAND REMEDIAL AREA

POST-EXCAVATION FLOOR SAMPLES							
NO.	DESCRIPTION	DATE	NORTH	EAST	ELEV. (FT.) *	PCB (PPM)	FOLLOW UP SAMPLE NO.
21	PES3101901	10/19/93	251220.2	727628.6	79.0	0.3U	NO
22	PES3101902	10/19/93	251222.8	727650.1	80.3	1U	NO
23	PES3101903	10/19/93	251225.9	727674.3	80.5	1U	NO
24	PES3101904	10/19/93	251194.1	727630.1	85.2	760	YES PES3102501
25	PES3101905	10/19/93	251160.4	727650.1	79.8	8.4	YES PES3102504
26	PES3101906	10/19/93	251183.1	727666.2	79.0	1U	NO
27	PES3101907	10/19/93	251195.0	727704.3	79.9	0.3U	NO
28	PES3101908	10/19/93	251200.0	727730.3	79.9	0.4U	NO
29	PES3101909	10/19/93	251218.8	727744.6	78.8	1U	NO
30	PES3101910	10/19/93	251134.8	727666.0	79.3	1U	NO
31	PES3102501	10/25/93	251194.4	727630.5	85.2	40	YES PES3111803
32	PES3102502	10/25/93	251195.3	727644.9	80.5	17	YES PES3102503
33	PES3102503	10/25/93	251195.3	727644.9	79.5	4.8	YES **
34	PES3102504	10/25/93	251160.1	727648.7	80.0	1.5	YES **
46	PES3111803	11/18/93	251194.2	727628.9	81.7	25	YES PES3112001

15	PES3062415(B)	06/24/93	251224.7	727735.8	80.1	1.4	YES PES3062415(C)
16	PES3062417(B)	06/24/93	251233.4	727684.6	80.3	3.0	YES PES3062417(C)
17	PES3062419(B)	06/24/93	251236.2	727634.6	79.7	1.3	YES PES3062419(C)
18	PES3062415(C)	06/24/93	251224.3	727734.3	80.1	0.6	NO
19	PES3062417(C)	06/24/93	251232.7	727688.0	80.1	0.6	NO
20	PES3062419(C)	06/24/93	251238.5	727635.0	80.3	0.1U	NO

The Wetland Delineation Line as shown hereon combines the outer limits of the U.S. Army Corps of Engineers Boundary and Bordered Vegetated Wetland Line as shown on Plan "WETLANDS RESOURCE MAP" dated 31 Dec. '90 by DANSON SURVEYING AND ENGINEERING CO.
